CALIFORNIA DIVISION OF MINES AND GEOLOGY

FAULT EVALUATION REPORT FER-160

Nunez Fault, Fresno County, California

Earl W. Hart
March 23, 1984

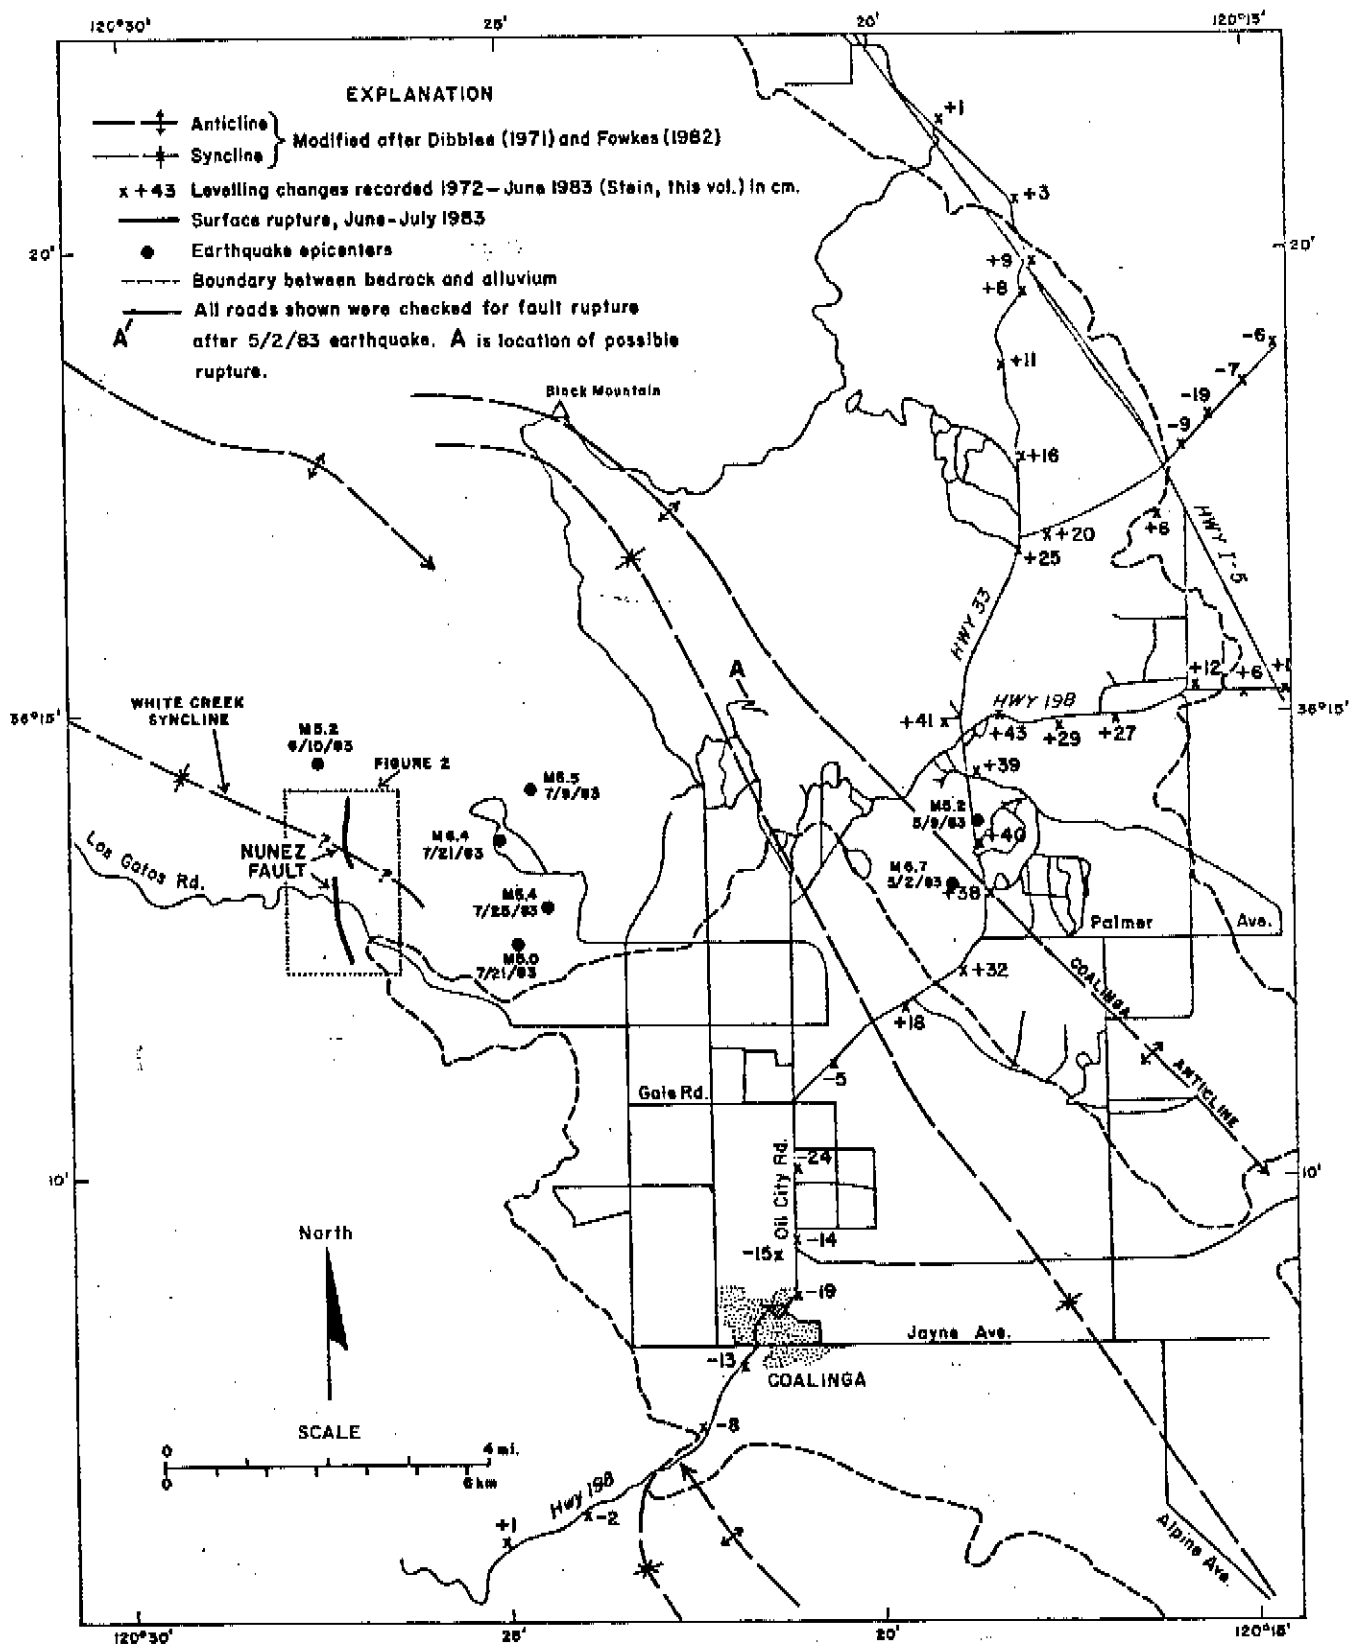
Figure 1. Map showing locations of 1983 Coalinga earthquakes, associated fault rupture, and other data. (Map reproduced from Hart and McJunkin, 1983, Fig. 1.)

As indicated above, rupture along the Nunez fault was associated with several June and July 1983 earthquakes (plotted on Fig. 1), all of which show first motion data and hypocenters consistent with displacement at depth on the east-dipping Nunez fault (Eaton and others, 1983). These earthquakes were considered as aftershocks of the May 2, 1983 M6.7 earthquake, which was not associated with surface faulting (one minor exception--see Hart and McJunkin, 1983). However, 43cm of uplift did occur on the Coalinga nose structure (see Fig. 1) in association with the Coalinga earthquakes (Stein, 1983).

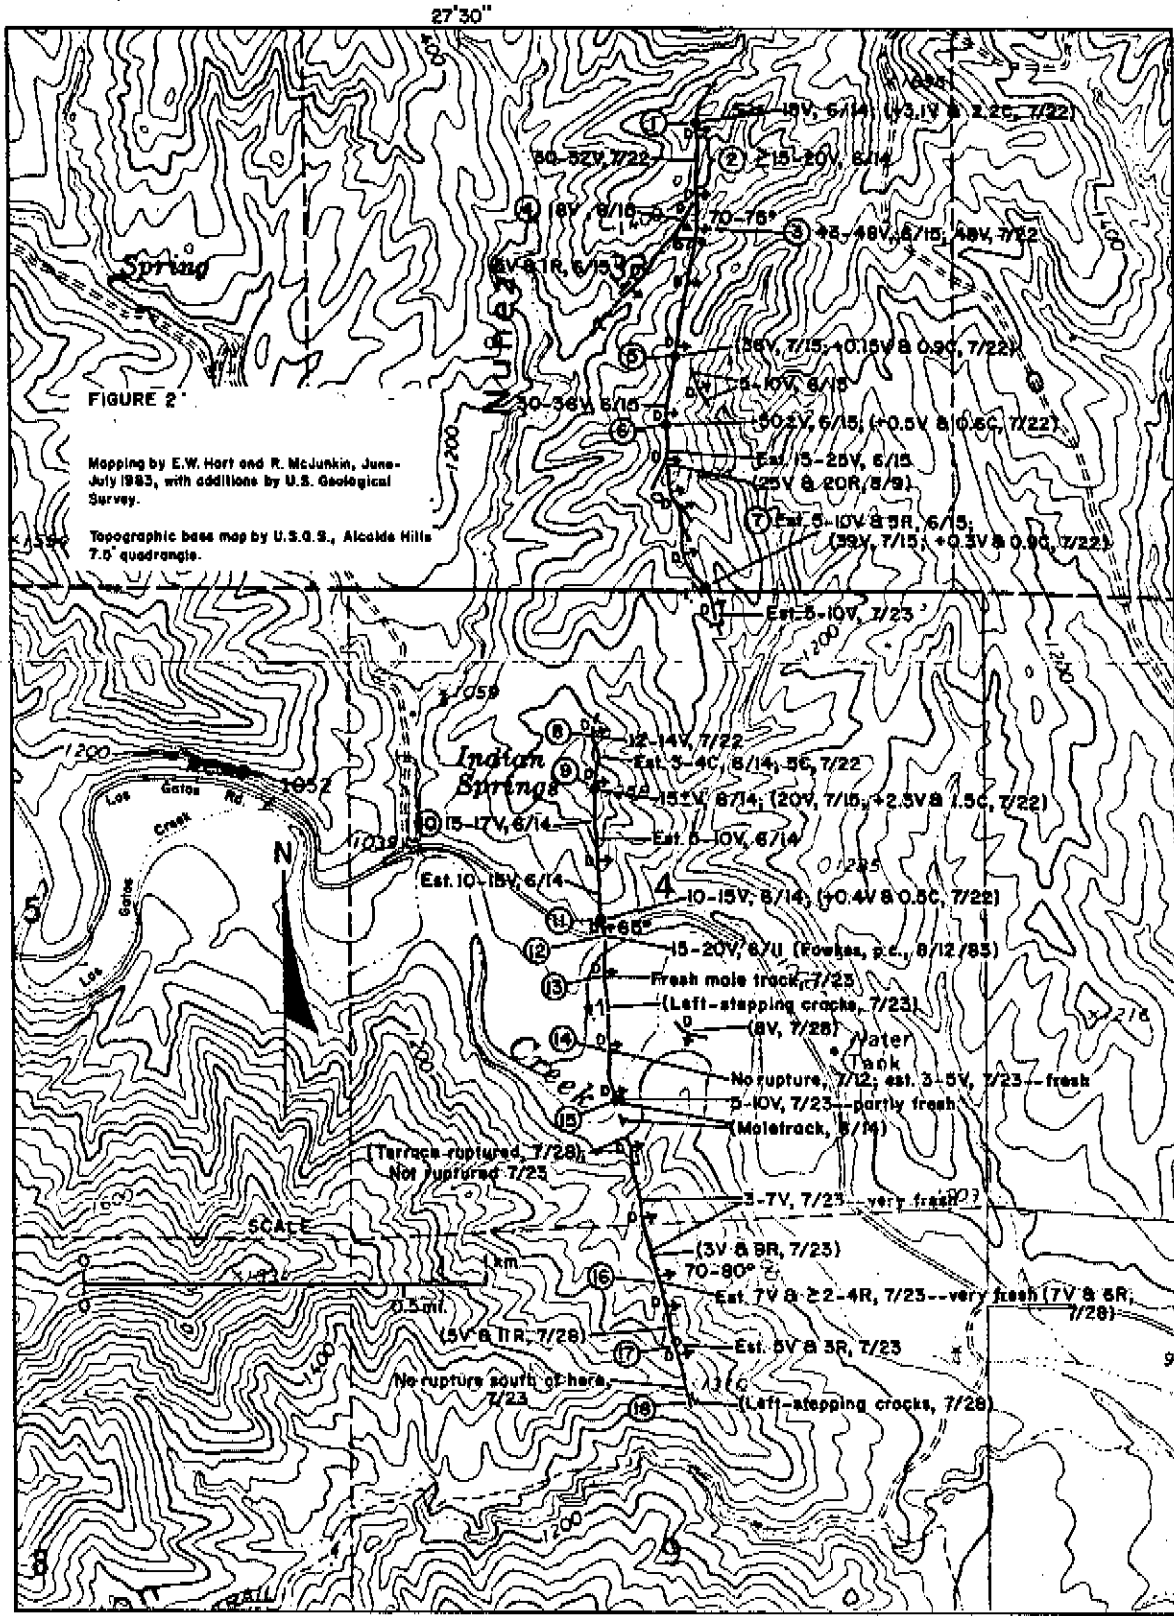
Figure 2 (FER - 100). Trace of surface faulting along Nunez fault, associated with the Coalinga, California, earthquakes of June 10 and July 9, 21, and 25, 1983.

As can be seen on Figure 2, there are two principal zones of surface rupture, which developed over a distance of 3.3km with a maximum net slip of about 60cm of reverse displacement occurring on the northern segment (locality 3, Table 1 and Figure 2). A substantial right-lateral component of slip also was recorded at localities 1 and 6. The southern segment of rupture had at least 20cm of reverse slip locally and a consistent component of right slip south of Los Gatos Road, reaching a maximum of 11cm near locality 17. Several minor, but distinct, secondary rupture zones also were mapped (Figure 2).

Locality	Observations
1.	Fresh, 18 cm-high, west-facing compressional scarp with extensional cracks on upthrown block, 6/14; aligns with other scarps and moletrack features to N and S. Scarp first seen by rancher on 6/11 or 6/12 (J. Nunez, p.c., 6/13). USGS measured 3.1 cm additional uplift and 2.2 cm shortening of monument line (established 7/15) just S of road on 7/22; no additional slip measured 7/27. Data indicate reverse movement on east-dipping fault associated with earthquakes of 6/10, 7/9(?), and 7/21.

2.	Continuous, narrow zone of ruptured ground with west-facing scarps along outer edge of pre-existing, sidehill bench on east-facing slope. Estimated vertical displacement of 15 to 20 cm or more on 6/14 along east-dipping reverse fault. Offsets appeared somewhat larger on 7/22, with maximum scarp height of 30-32 cm observed at one point.

3.	Fresh, well-developed, west-facing, compressional scarp along cattle trail in bottom of gully; estimated offset to be 43 to 48 cm on 6/15. Fissures and moletracks to N and S in moist soil adjacent to gully indicate 70° to 75° east-dipping reverse fault. Observed offset was 48 cm on 7/11. USGS observed offsets of 42 cm on 6/15 and 48 cm on 7/13. However, later USGS level surveys along the centerline of cattle trail indicate 57 cm uplift on 7/15, plus 0 to 5 cm on 7/22, and 0 cm on 7/27.

4.	Very fresh, overhanging scarp 18 cm high with fault plane exposed in soil along sidehill bench on 6/15; fault plane strikes N 50° E and dips 67° SE.

5.	Large, west-facing scarp and associated moletrack features near crest of ridge, indicate east-dipping reverse fault on 6/15. USGS monument line surveyed on 7/15 indicates 36 cm total uplift. On 7/22, USGS survey showed minor additional movement of 0.15 cm uplift and 0.9 cm compression. No movement detected 7/27.

6.	Fresh compressional scarp in soil with east-side-up vertical offset estimated to be about 50 cm on 6/15. Nearby USGS monument line indicated 50+20 cm total uplift on 7/15 with additional 0.5 cm uplift and 0.6 cm compression on 7/22. No movement detected 7/27. About 100 cm to south, USGS observed 20 cm of right-lateral slip on 8/9 along a previously observed 25 cm-high scarp. This right slip component was not previously observed, but it may have been overlooked initially (M.J. Rymer, p.c.).

7. Zone of fresh left-stepping moletracks and cracks along general southwest-facing scarp; estimated roughly 5 to 10 cm of vertical uplift on individual scarps and roughly 5 cm right slip offset at fence on 6/15, but accurate measurements not possible. Fault rupture could not be traced to south in tall grass on 6/15, but discontinuous, 3 to 4 m wide zone of low moletracks, west-facing scarps, and new(?) cracks could be followed southward an additional 150 m with difficulty on 7/23. USGS monument-line surveys indicated 39±3 cm vertical uplift across the scarp on 7/15 with an additional 0.3 cm uplift and 0.9 cm compression on 7/22. No tectonic change reported for 7/27 survey.

8. East-west wire fence along steep, east-draining gully observed to be shortened (slack wire) across the projection of the fault on 6/14. Observations on 7/22 suggest further shortening, crudely measured to be 5 cm.

9. Fresh west-facing, moletrack-like scarp estimated to be about 15 cm high on 6/14 and possibly a little higher on 7/22. USGS measurements along monument line indicated the scarp to be 20 cm high on 7/15; additional uplift of 2.3 cm and shortening of 1.5 cm were measured 7/22. No additional movement detected 7/27.

10. Two fresh(?) scarplets observed 7/22 in loose soil of recently used foot path, possibly suggesting renewed uplift along degraded, west-facing scarp initially observed 6/13. Total scarp height estimated to be 15 to 17 cm on 7/22. Continuous 5-10 cm high scarp observed 6/14 this vicinity, but specific locality not measured or estimated at that time.

11. Well-defined, 1 to 2 m wide zone of moletracks, compressional scarp, and cracks; scarp faces west and estimated to be 10 to 15 cm high on 6/13. USGS monument-line surveys indicate 0.4 cm additional uplift and 0.55 cm compression between 7/15 and 7/22. A 5 to 15 m wide zone of north-trending tension cracks open as much as 5 to 6 cm, observed 6/13 in soil immediately east of the fault, suggesting that east-dipping fault plane flattens upward.

12. Paved road offset on 6/10 and west-facing scarp observed to be 15-20 cm high on 6/11 (E.J. Fowkes, p.c., 8/12). Road was repaved 6/14 and no cracks developed thereafter through 7/27. However, surveys of recently-established USGS nail-line indicated 2 mm of east-side-up movement between 7/23 and 7/27. Pre-existing fault with fresh fractures was exposed in roadcut; dip is about 60-70°E in bedrock, but dip of fault flattens upward (to west) in soil and appears to connect with moletrack/scarp feature in soil. Tension cracks, open to 2 cm, occur in conglomerate and sandstone east of fault and align with open cracks in soil to north.

13. Narrow sinuous west-facing moletrack 7 to 10 cm high, with fresh, delicate features seen in soil of recently grazed field (young terrace) on 7/23. Moletrack indicates probable slip along reverse fault associated with 7/21 earthquakes. Possible cracks and moletrack observed nearby (?) on 6/11 (Fowkes, 6/13). Open cracks in narrow zone to south reported by USGS on 7/28 to be partly left-stepping, suggesting some right slip. Pre-existing(?), low, west-facing scarp in very young terrace surface suggests previous Holocene displacement.

14. Fresh, west-facing scarplets in dirt road estimated to be 3 to 5 cm high on 7/23. No fault features or cracks observed at this locality on 7/12; indicates reverse slip along east-dipping fault associated with 7/21 earthquakes.

15. Low, sinuous moletrack and west-facing scarp about 5 to 10 cm high observed 7/23, partly very fresh and more or less continuous with newly ruptured ground to north. Some discontinuous moletracks reported in this area by E.J. Fowkes on 6/11 and M. Rymer (USGS) on 6/14. Probable rupture on 6/10 and 7/21.

16. Zone of very fresh, left-stepping cracks and west-facing scarp in cattle trail on 7/23. Estimate 7 cm uplift and at least 2 to 4 cm right slip along 70-80°E-dipping fault plane exposed in soil; fault plane is grooved, showing oblique slip (photo 7). USGS measured 7 cm vertical and 6 cm right-slip displacement on 7/28. About 100 m to south, USGS measured maximum of 11 cm right slip on 7/28, more than recognized by CDMG on 7/23. Freshness of features indicates reverse and right-lateral displacements along steeply east-dipping fault associated with 7/21 and possibly 7/25 events. No previous clear evidence of fault-rupture reported for this general locality prior to 7/23 by CDMG or USGS although "crack zone" reported in vicinity about 6/28 (P. Hughes of Chevron, Inc., p.c., 8/11).

17. Fresh, well-developed, left-stepping cracks and sharply defined moletracks in 1 to 2 m-wide zone observed 7/23. About 3 cm right-lateral slip is indicated by extensional opening of cracks. Consistent west-facing scarps indicate about 5 cm vertical offset (up on east). USGS installed monument line on 7/27; USGS observed 1.5 cm vertical and 2 cm right-lateral offset on 7/28.

18. Zone of left-stepping cracks (without scarp) observed by USGS on 7/28; indicates minor right-slip displacement. Left-stepping cracks not observed by CDMG on 7/23.
