**STATE OF CALIFORNIA
 SPECIAL STUDIES ZONES**

LITTLEROCK QUADRANGLE

OFFICIAL MAP

Effective: July 1, 1974

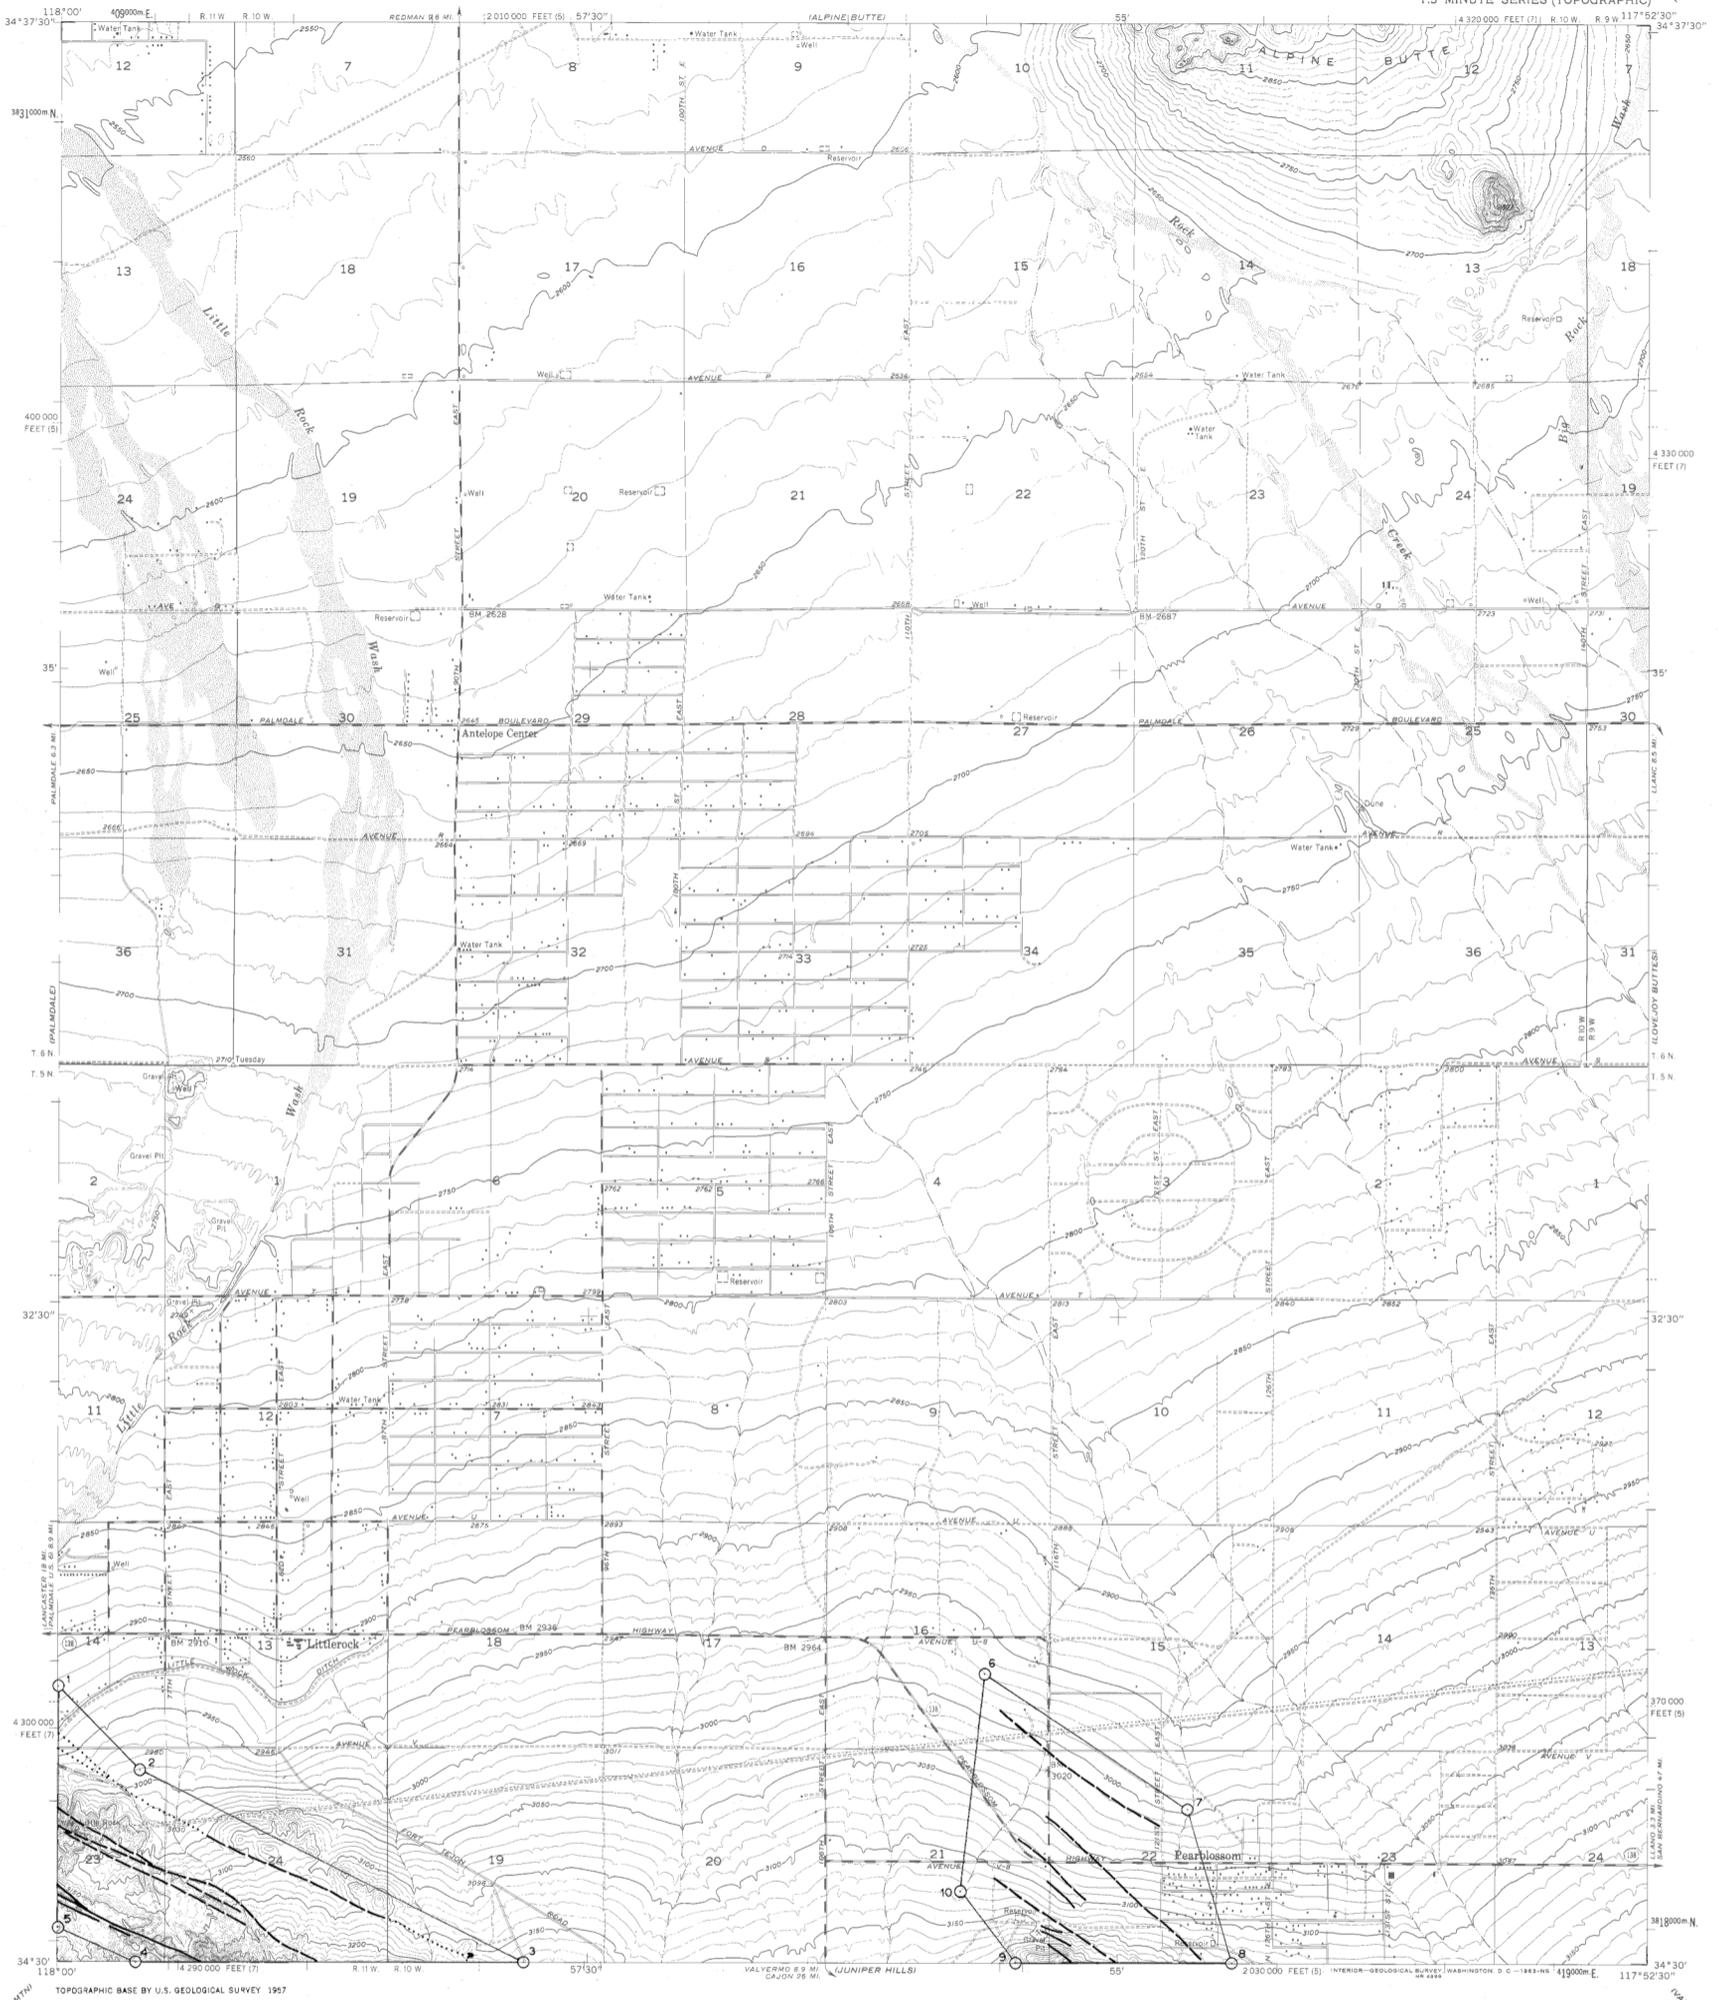
Faults considered to have been active during Quaternary time; solid line where accurately located, long dash where approximately located, short dash where inferred, dotted where concealed; query (?) indicates additional uncertainty. Evidence of historic offset indicated by year of earthquake-associated event or C for displacement caused by creep or possible creep.

Aerial photo lineaments (not field checked); based on youthful geomorphic and other features believed to be the results of Quaternary faulting.

These are delineated as straight-line segments that connect consecutively numbered turning points so as to define one or more special studies zone segments.

Seaward projection of zone boundary.
