**STATE OF CALIFORNIA
 SPECIAL STUDIES ZONES**

PAINTED ROCK QUADRANGLE

OFFICIAL MAP

Effective: July 1, 1974

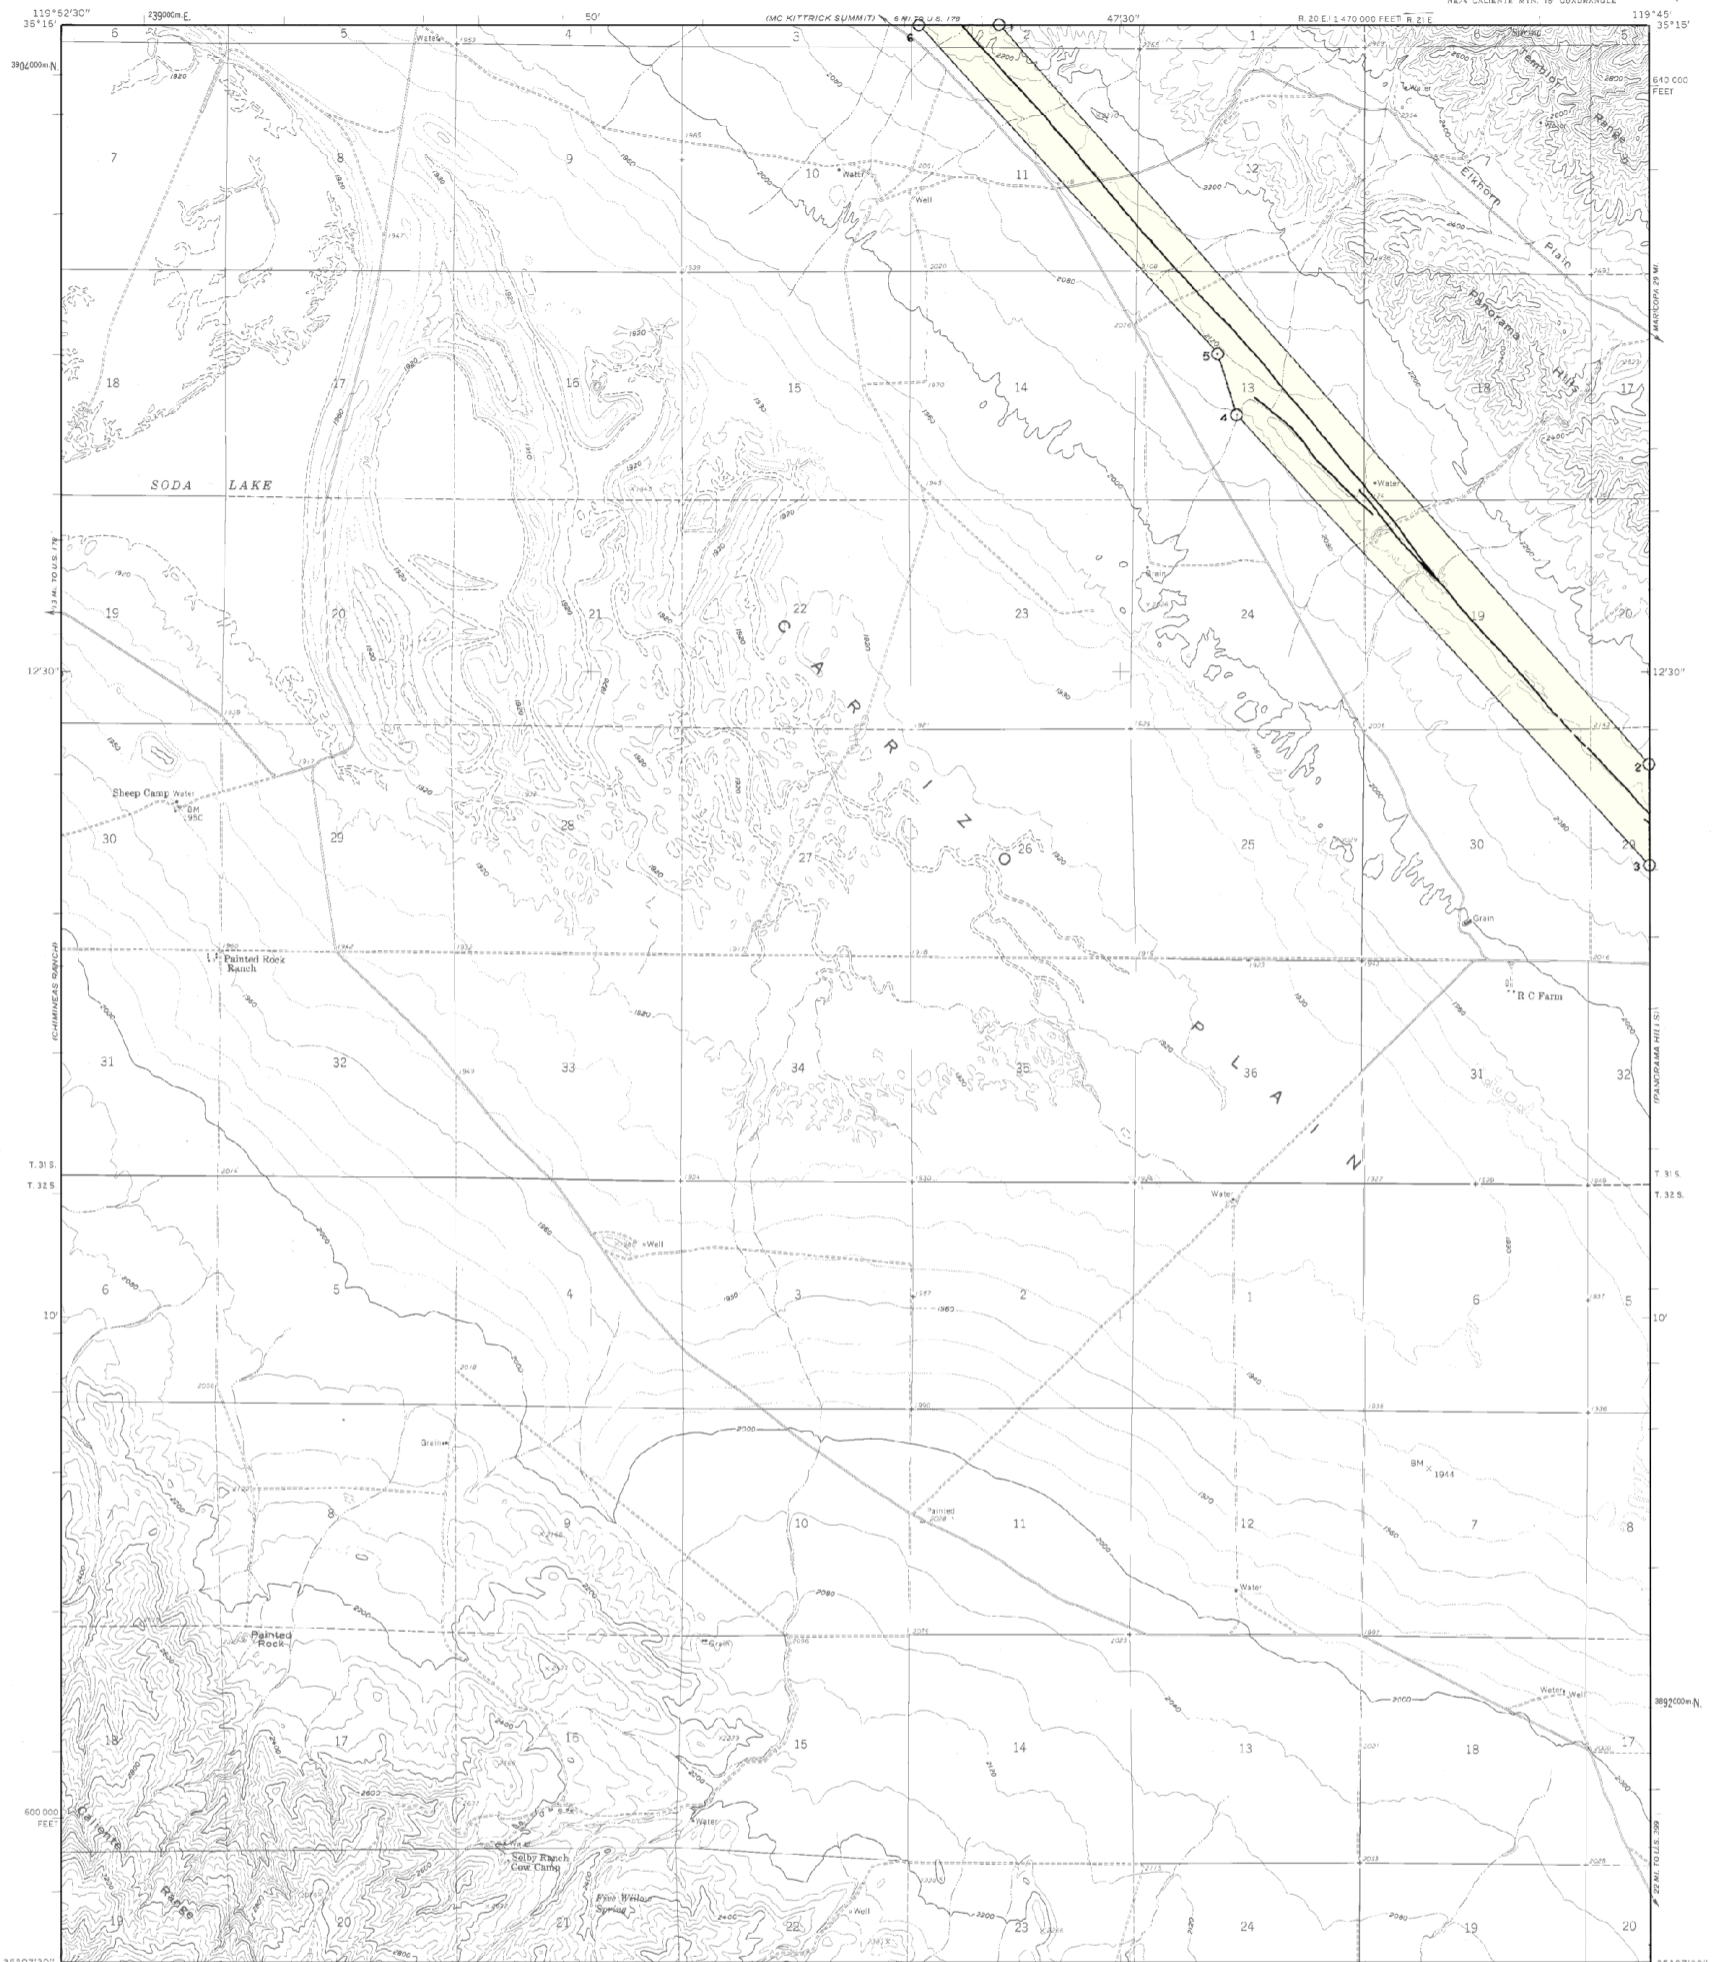
Potentially Active Faults

Faults considered to have been active during Quaternary time; solid line where accurately located, long dash where approximately located, short dash where inferred, dotted where concealed; query (?) indicates additional uncertainty. Evidence of historic offset indicated by year of earthquake, associated event or C for displacement caused by creep or possible creep.

Aerial photo lineaments (not field checked): based on youthful geomorphic and other features believed to be the results of Quaternary faulting.

Special Studies Zone Boundaries

These are delineated as straight-line segments that connect consecutively numbered turning points so as to define one or more special studies zone segments.
